# Chapter 2 PROGRESS ON THE WORLD TRADE CENTER INVESTIGATION

#### 2.1 STATUS OF DATA COLLECTION EFFORTS

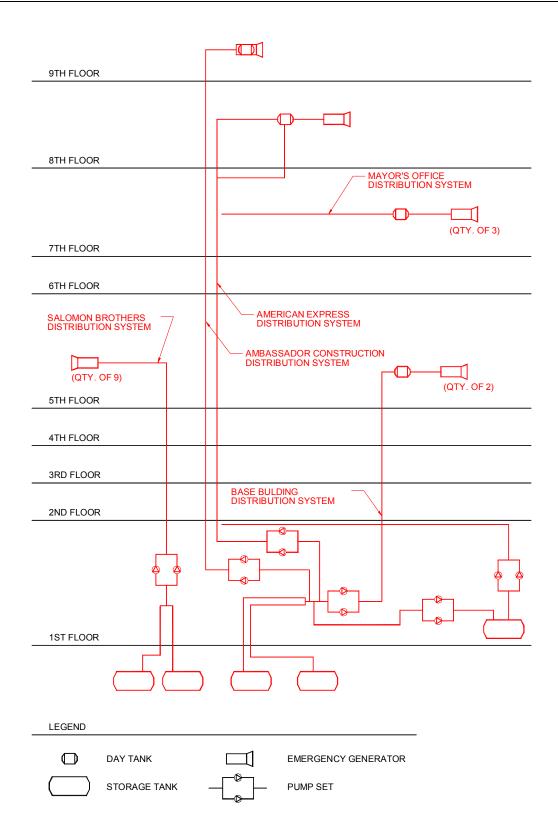
Figure 2–1. Locations of emergency generators and fuel tanks in WTC 7.

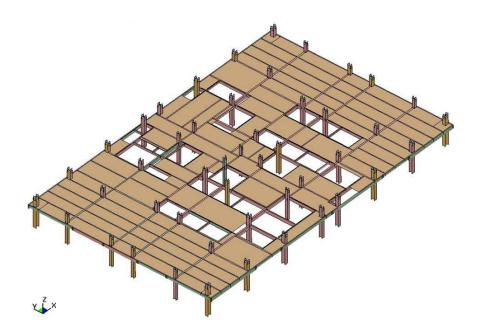
Figure 2–4. Model of the 96th floor and columns of WTC 1.

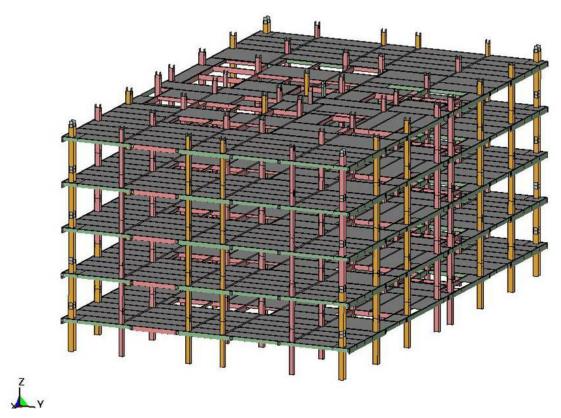
Figure 2–5. Model of the core of WTC 1, floors 94–98.

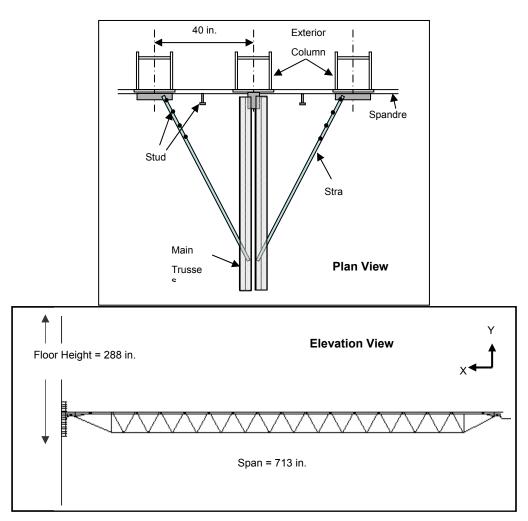
Figure 2–10. Truss model.

- Buckling of truss members
- Failure of knuckle leading to loss of composite action
- Failure of studs on the strap
- Failure of stud between the spandrel and the concrete slab
- Failure of truss resistance welds between the web diagonals and the chords
- Failure of the exterior and interior truss seats

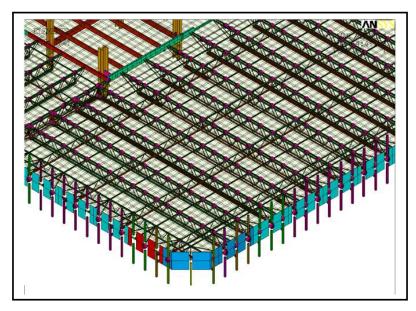
The model was developed by translating a SAP2000 full floor model developed under Project 2 into ANSYS format and validating the analysis results against the SAP2000 model for design loads. A corner of the full floor model is shown in Fig. 2–11.

Figure 2–11. Converted ANSYS model of floor 96.

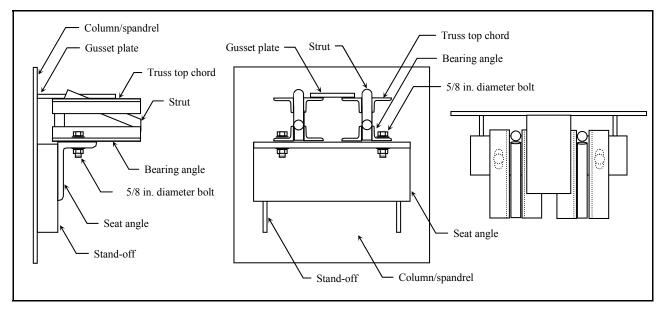
The horizontal and vertical load capacities of the twelve truss-to-column connection configurations on floor 96 have been calculated. These calculated capacities were used to develop simplified models of the connection behavior for use in the floor and exterior wall subsystem analyses. As an illustration, Fig. 2–12 shows a seated connection of the floor truss to the exterior wall of the tower (spandrel plate). The connection is designed to carry vertical floor loads and horizontal loads that are at least 2 percent of the column design load. These connections may be subjected to large horizontal forces, and the capacity of the exterior truss connection under such circumstances must be ascertained.

Figure 2–12. Exterior connection of the floor truss to the spandrel plate.

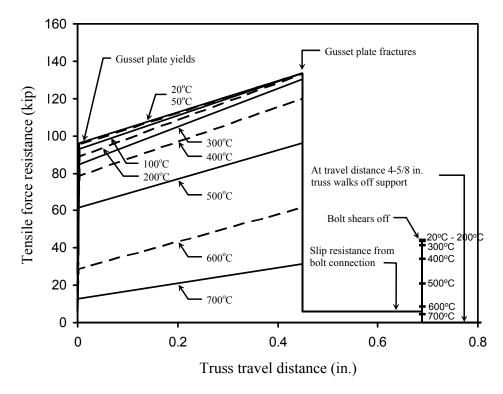
The failure modes considered for the truss-to-column connections are: (1) failure of the groove weld between gusset plate and spandrel, (2) failure of the fillet weld between the gusset plate and the truss top chord, (3) tensile failure of the gusset plate, (4) bolt shearing off, (5) bolt bearing, (6) bolt tear-out, and (7) block shear failure. Possible failure sequences are illustrated in Fig. 2–13. Of the seven exterior connections types that were analyzed, path A is the failure sequence most frequently followed, which is described as follows: first the gusset plate yields across its section and then fractures, followed by truss sagging and deformation and the bolts slipping until they bear against the edge of the slotted hole, then the bolt shears off, and finally the truss walks off the seat. The travel distance for the truss to walk-off of the seat is 4 5/8 in. Sequence (A) and typical tensile force resistance for an exterior seat is shown in Fig. 2–14.

Figure 2–14. Typical tensile force resistance of exterior seat connection.

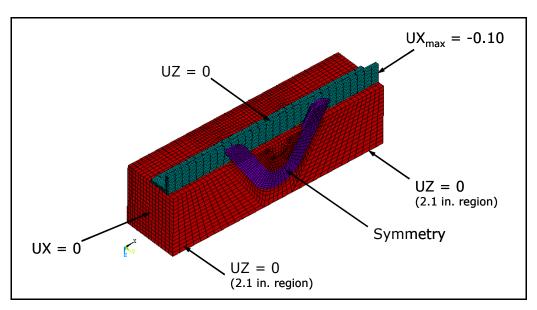
Figure 2–15 shows the FEM of the longitudinally loaded knuckle, representing one quarter of the knuckle test specimen. The ANSYS LS-DYNA program, which is part of the ANSYS software package for explicit nonlinear structural analysis, was used for the analysis of the knuckle tests as it had a concrete material model for nonlinear behavior. Solid steel elements were used for the knuckle and channel members and the Psuedo Tensor material model in LS-DYNA was used for the concrete. The knuckle-to-concrete interface was modeled as a bonded or no-friction contact. The finite-element analysis results of the knuckle capacity depended on the steel-concrete interface assumption of bonded or no-friction contact.

Figure 2–15. Finite element model of transversely loaded knuckle.

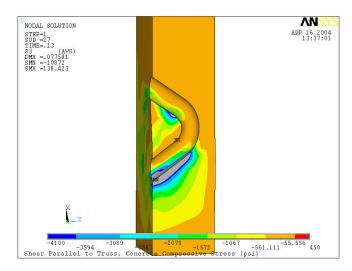
FEA results of the knuckle under longitudinal loading are shown in Fig. 2–19. Displacement results shown in Fig. 2–20 indicate a significant dependence on the characteristic of the interface between the steel and concrete. Results show that each knuckle has a capacity in the range of 15 klb to 35 klb, depending on the steel-to-concrete interface assumption. Results of longitudinal shear tests conducted by Laclede Steel in 1967, using normal weight concrete with an average compressive strength of 3,707 psi, indicate an average shear capacity of approximately 28.3 klb per knuckle. After adjusting for the strength of in-place light-weight concrete of 4,100 psi (i.e., multiplying 28.3 klb by the ratio of 4,100 to 3,707 psi), the longitudinal shear capacity of the knuckle is approximately 31 klb per knuckle. This is consistent with the finite element solution for the fully bonded case shown in Figure 2–21 (note results are for two knuckles). A shear capacity of approximately 30 klb per knuckle is used for subsequent analyses of the floor truss.

Figure 2–19. Compressive stress in longitudinal shear.

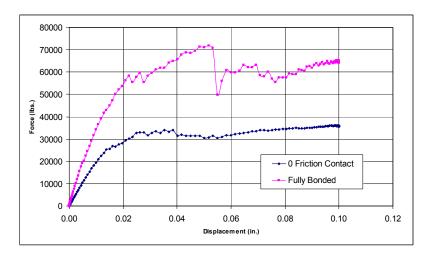
Figure 2–20. Shear force versus displacement for two knuckles under longitudinal shear.

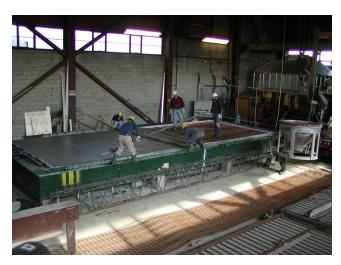
The test assemblies have been fabricated as shown in Fig. 2–22, and at this time, the concrete floor slabs are drying to the ASTM E 119 specified moisture condition under controlled conditions to obtain concrete design strength. The specimens are currently drying in a temperature/humidity controlled environment to achieve the ASTM E 119 prescribed moisture equilibrium.

Figure 2–22. Fabrication of 35 ft span ASTM E 119 test assembly.

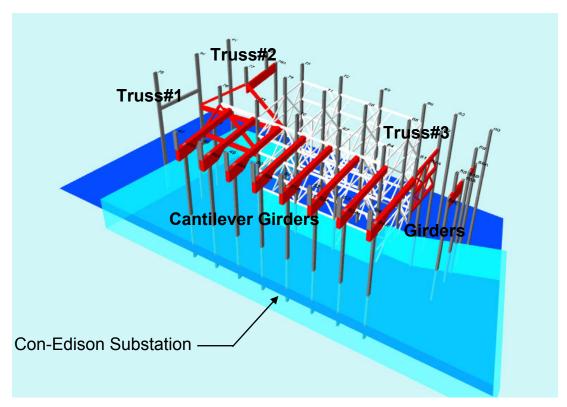
Figure 2–24. Transfer trusses and girders between the fifth and seventh floors.
